**UM-3732-98
1998 Oldsmobile Intrigue**

**In-depth
Vehicle
Occupant
Report**

The University
of Michigan
Transportation
Research Institute

Case Vehicle (A): 1998 Oldsmobile
 Type: Intrigue, 4-door sedan
 Driver: 38-year-old female
 CDC: 01-FDEW-2

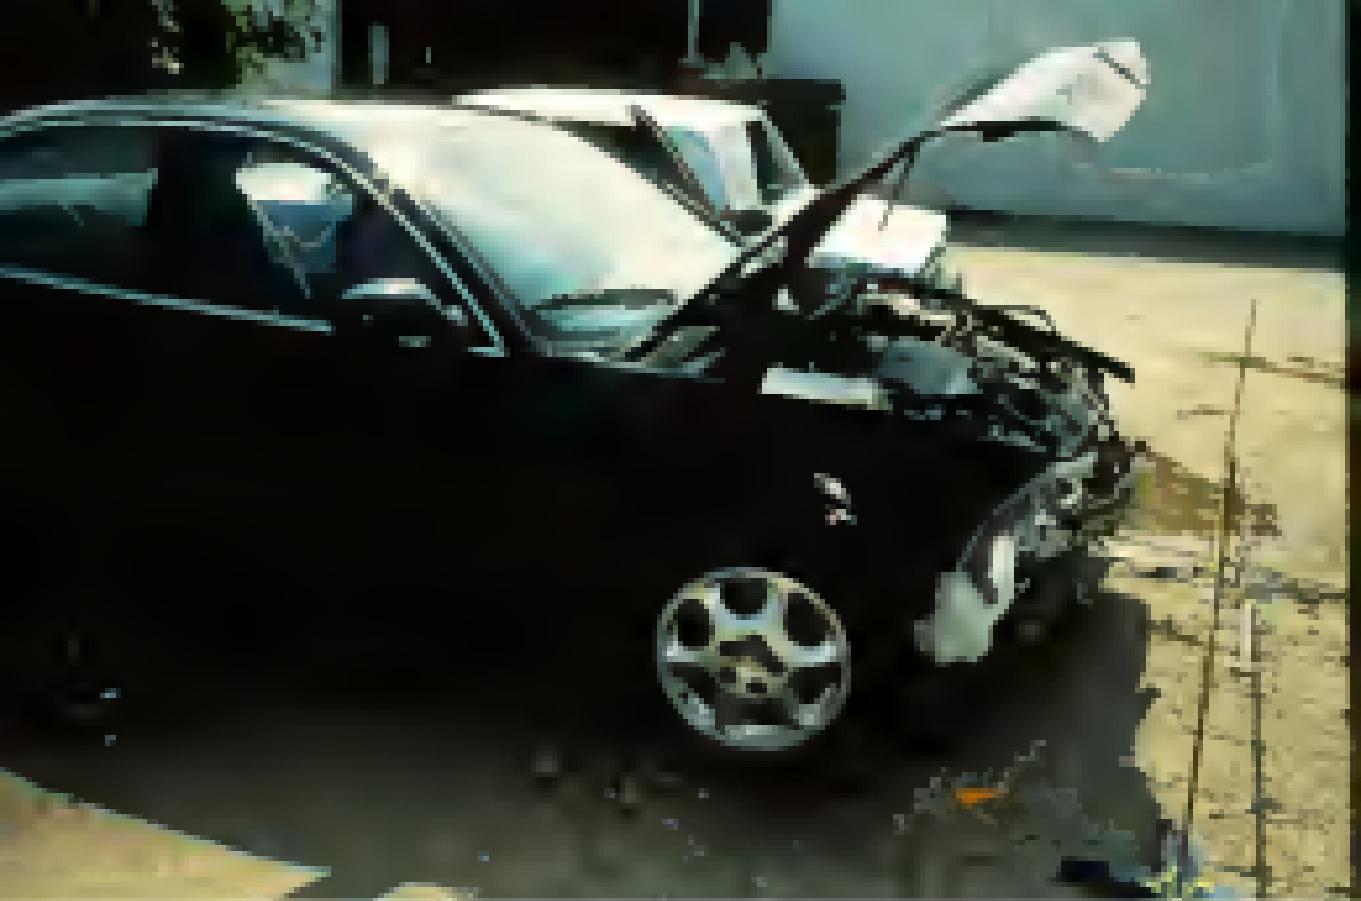
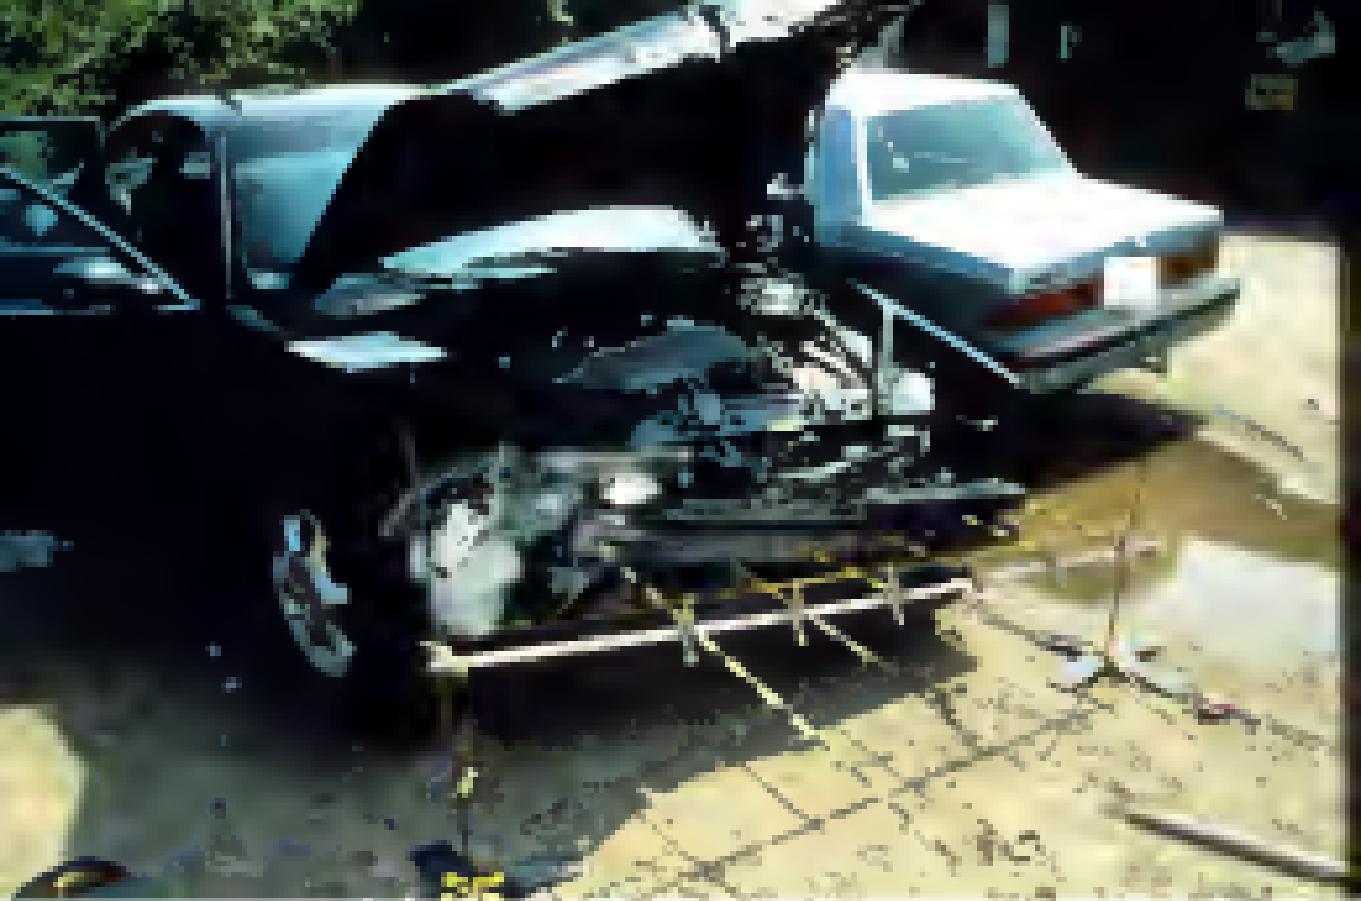
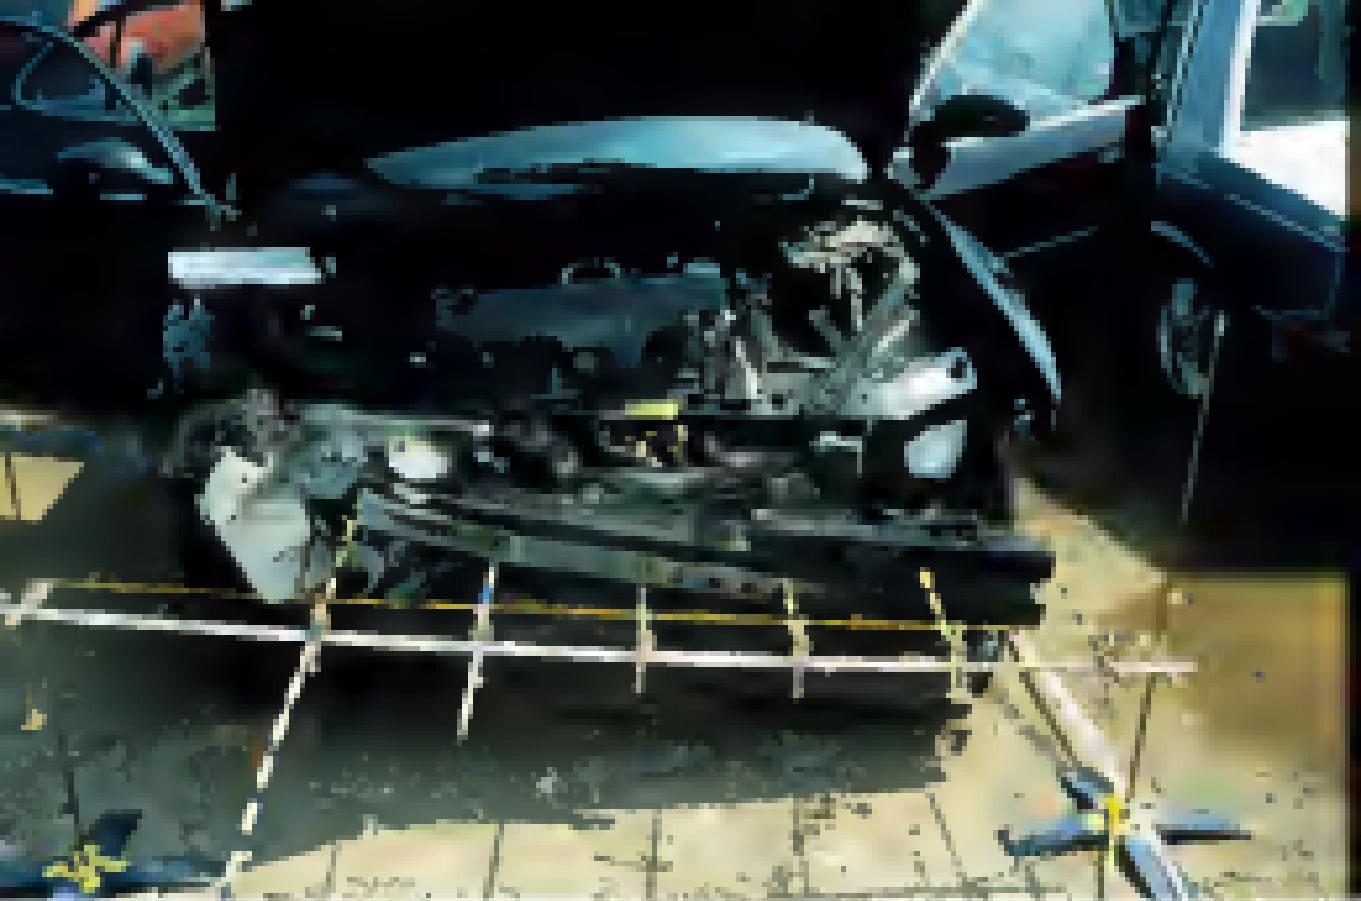
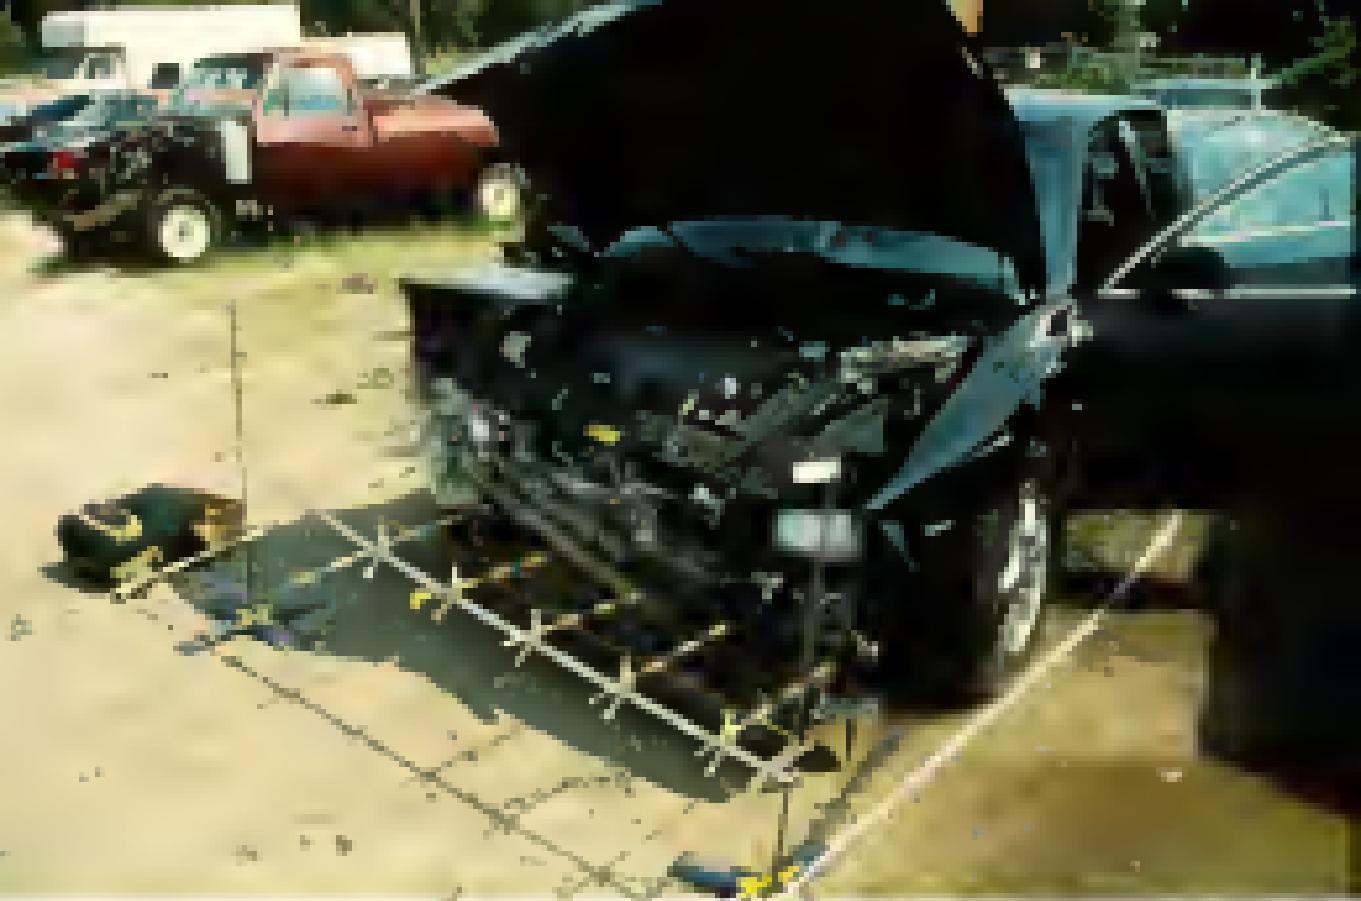
Using the SMASH accident-reconstruction program and c-values measured for (slides 4, 5, 6, 7, 8,) case vehicle (A), the following impact severity was calculated:

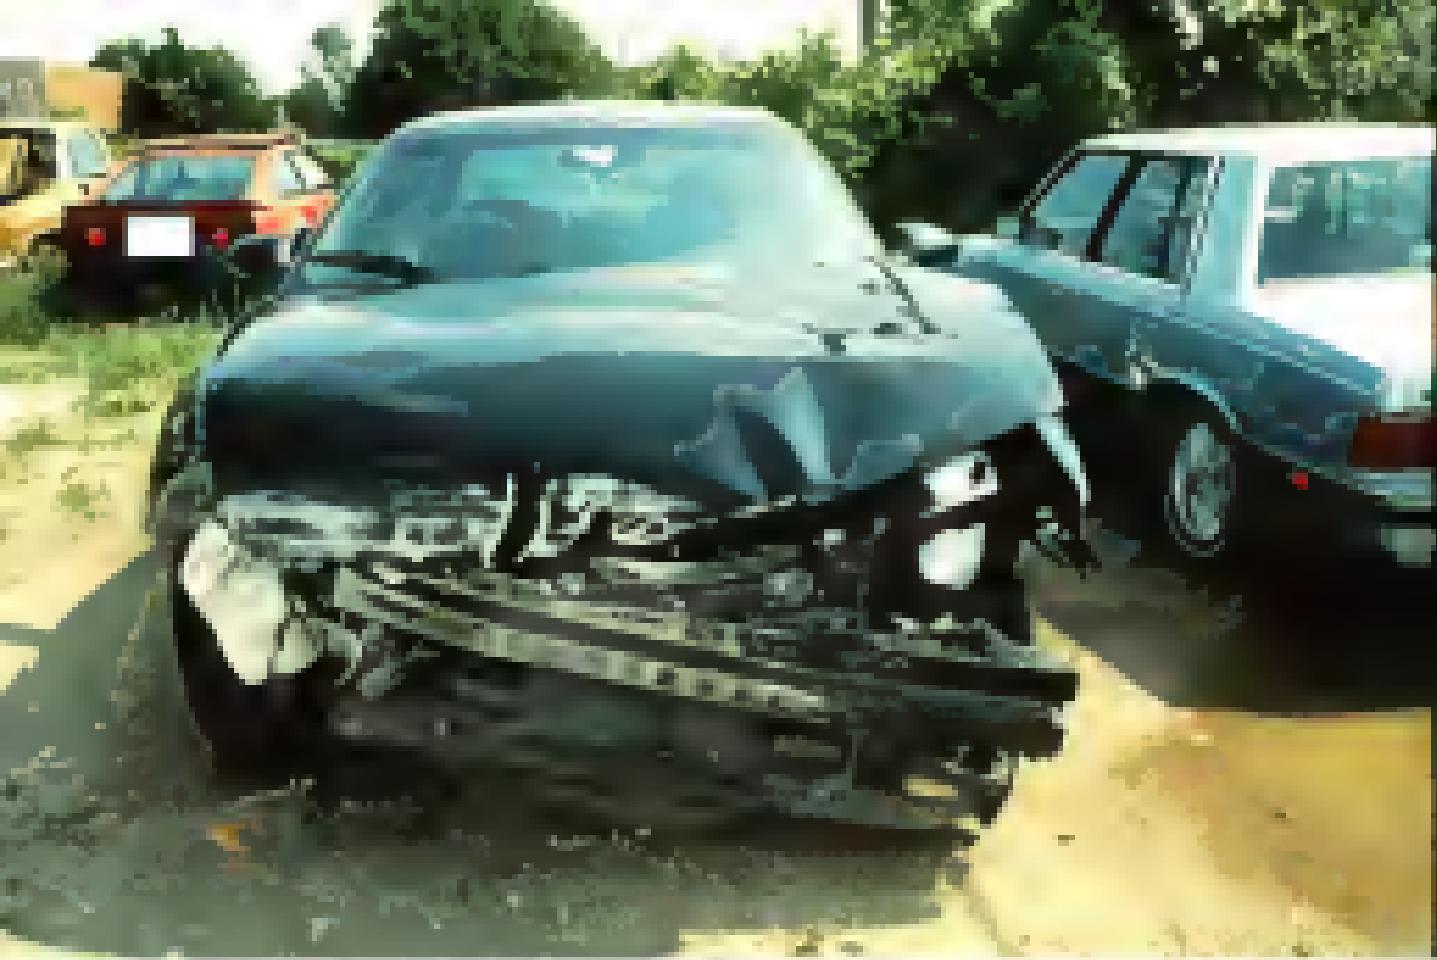
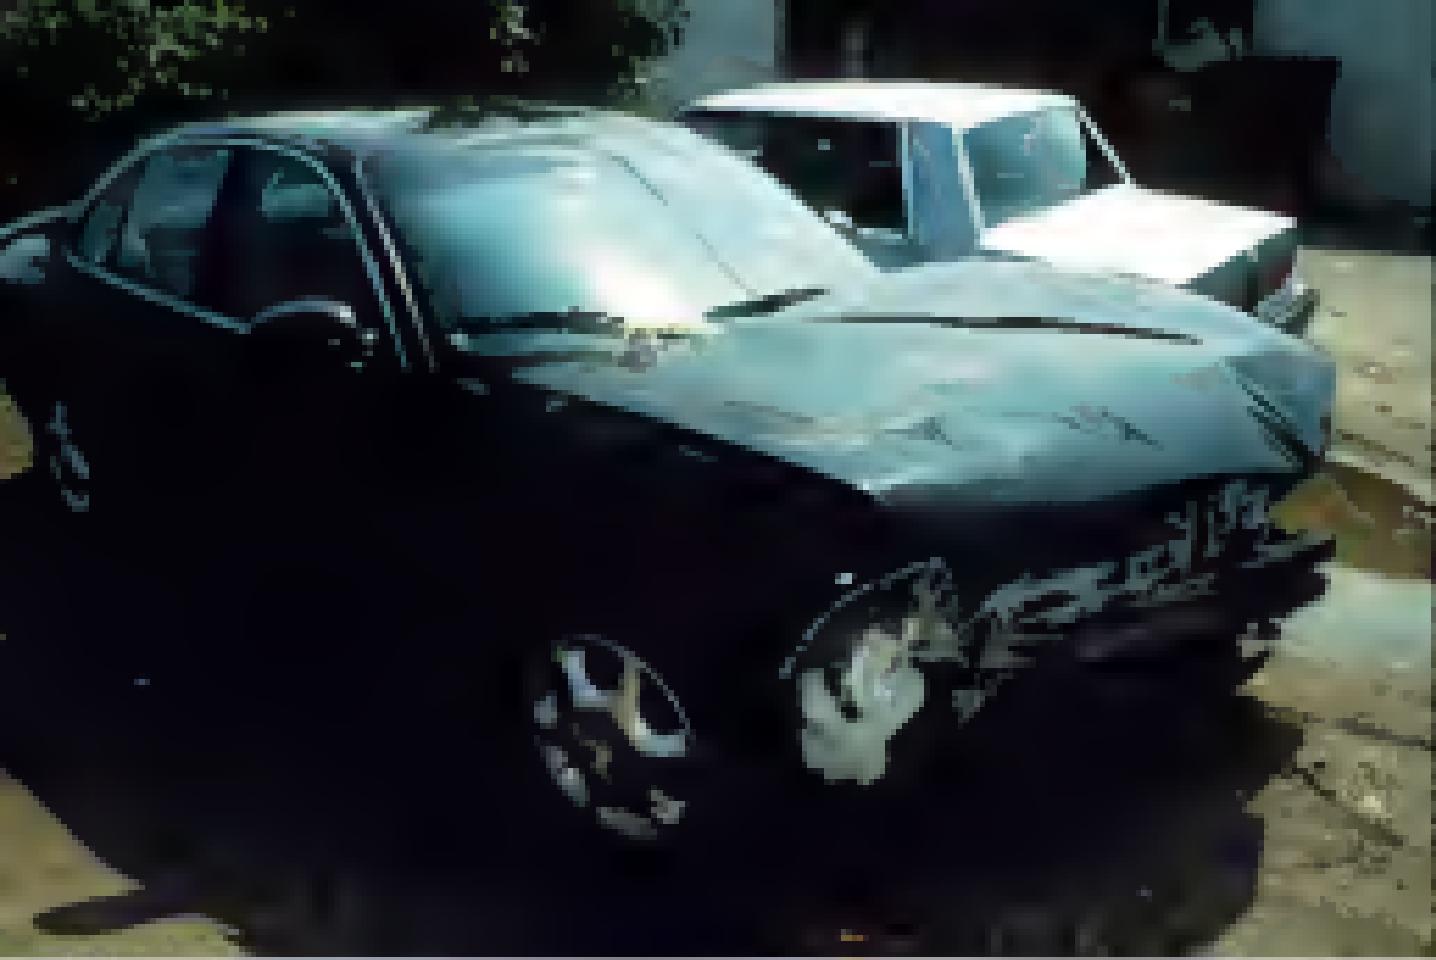
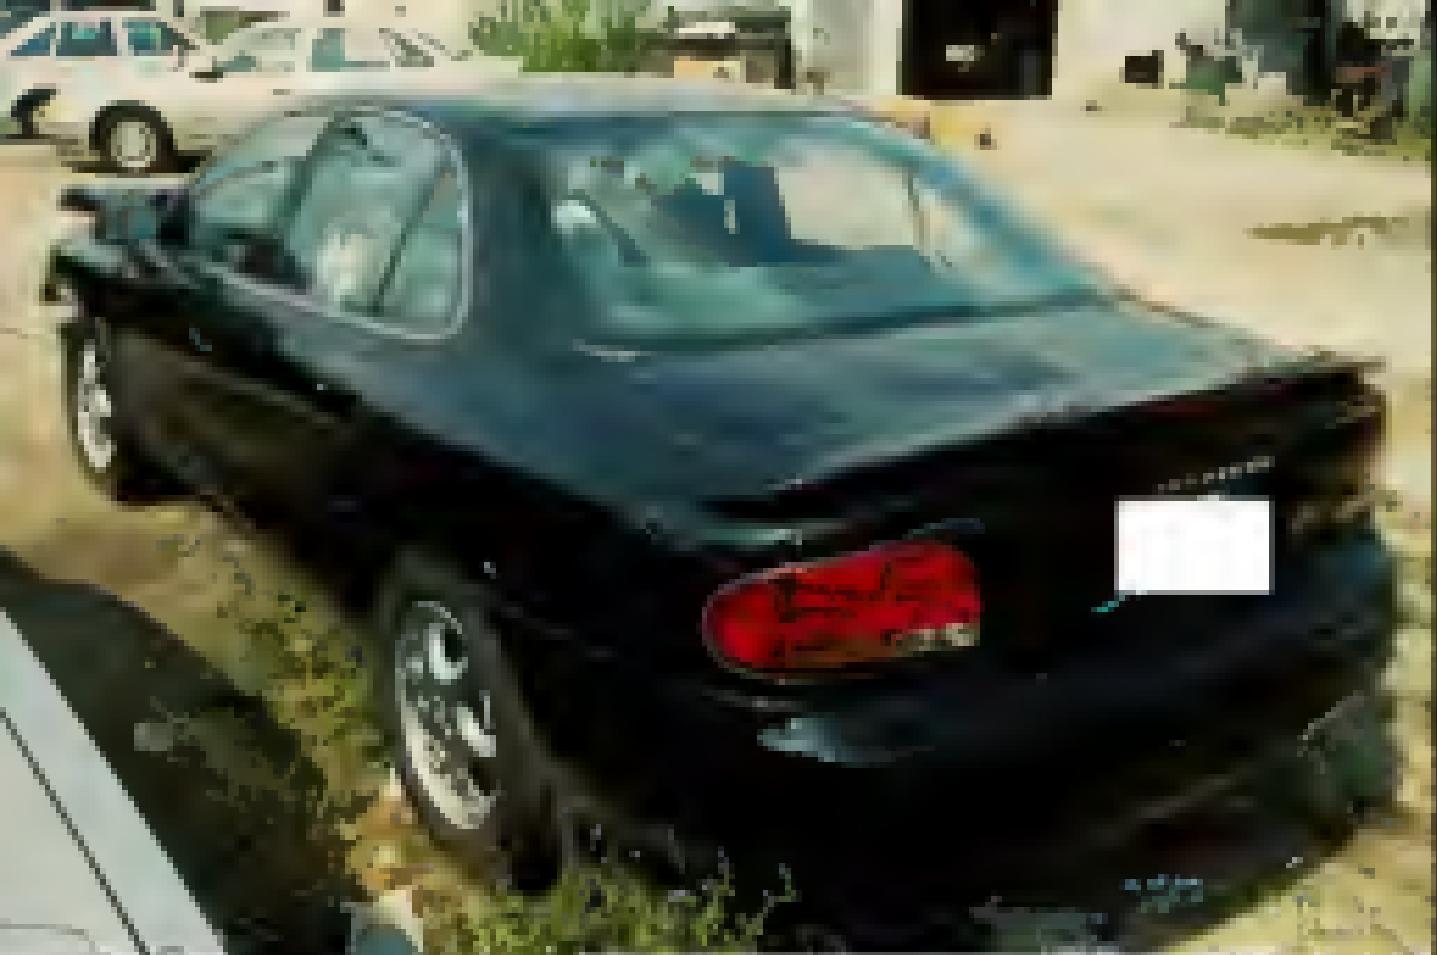
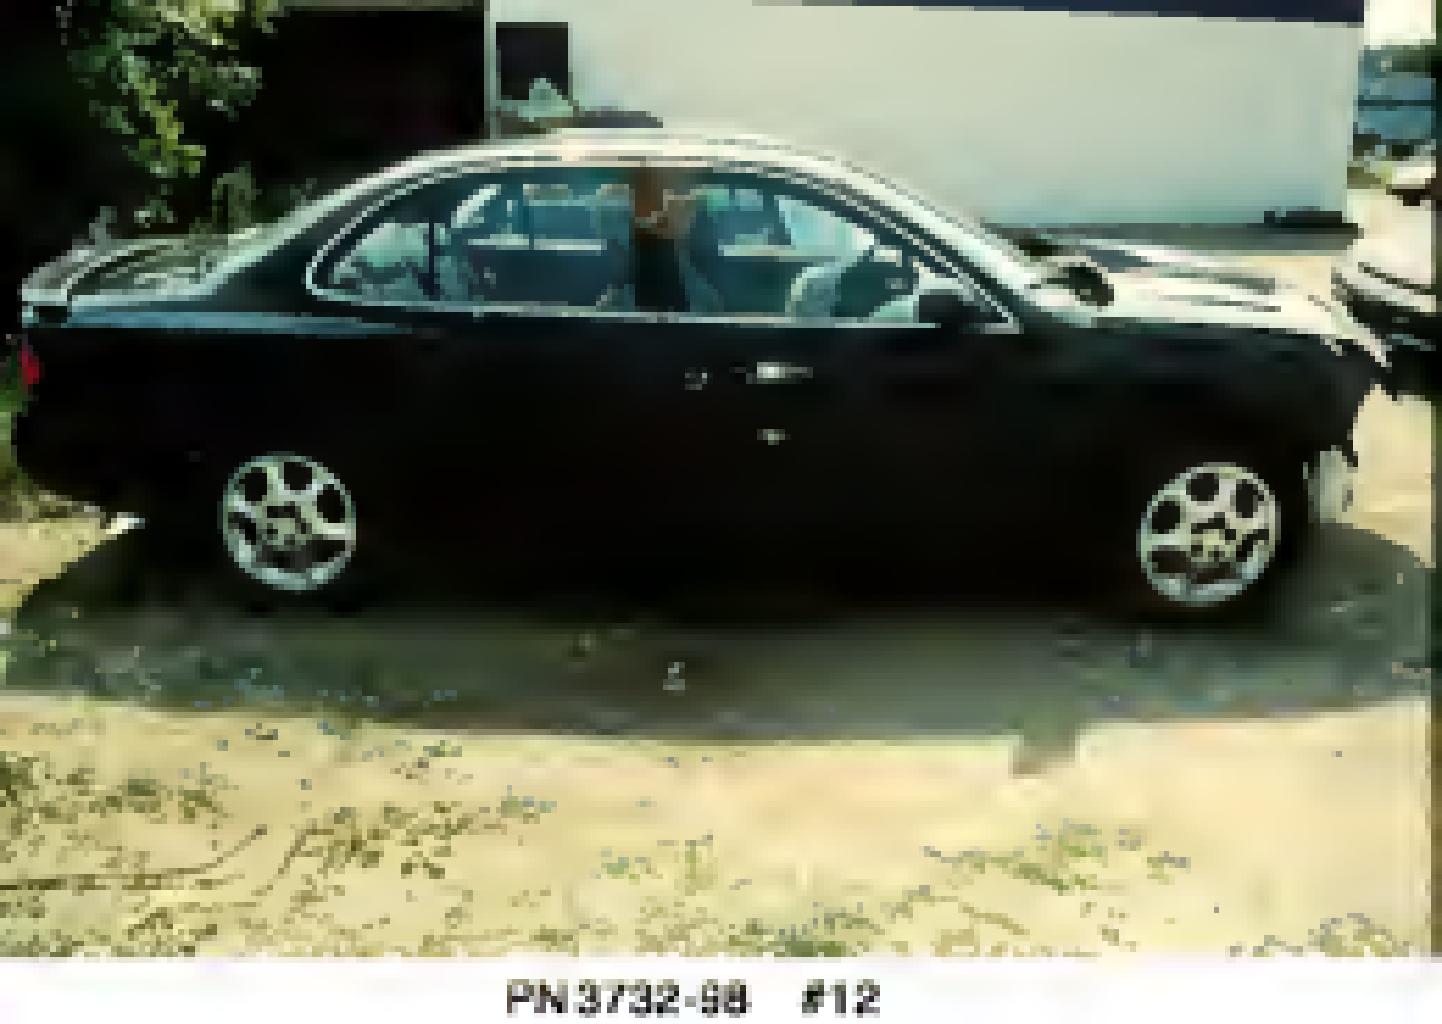
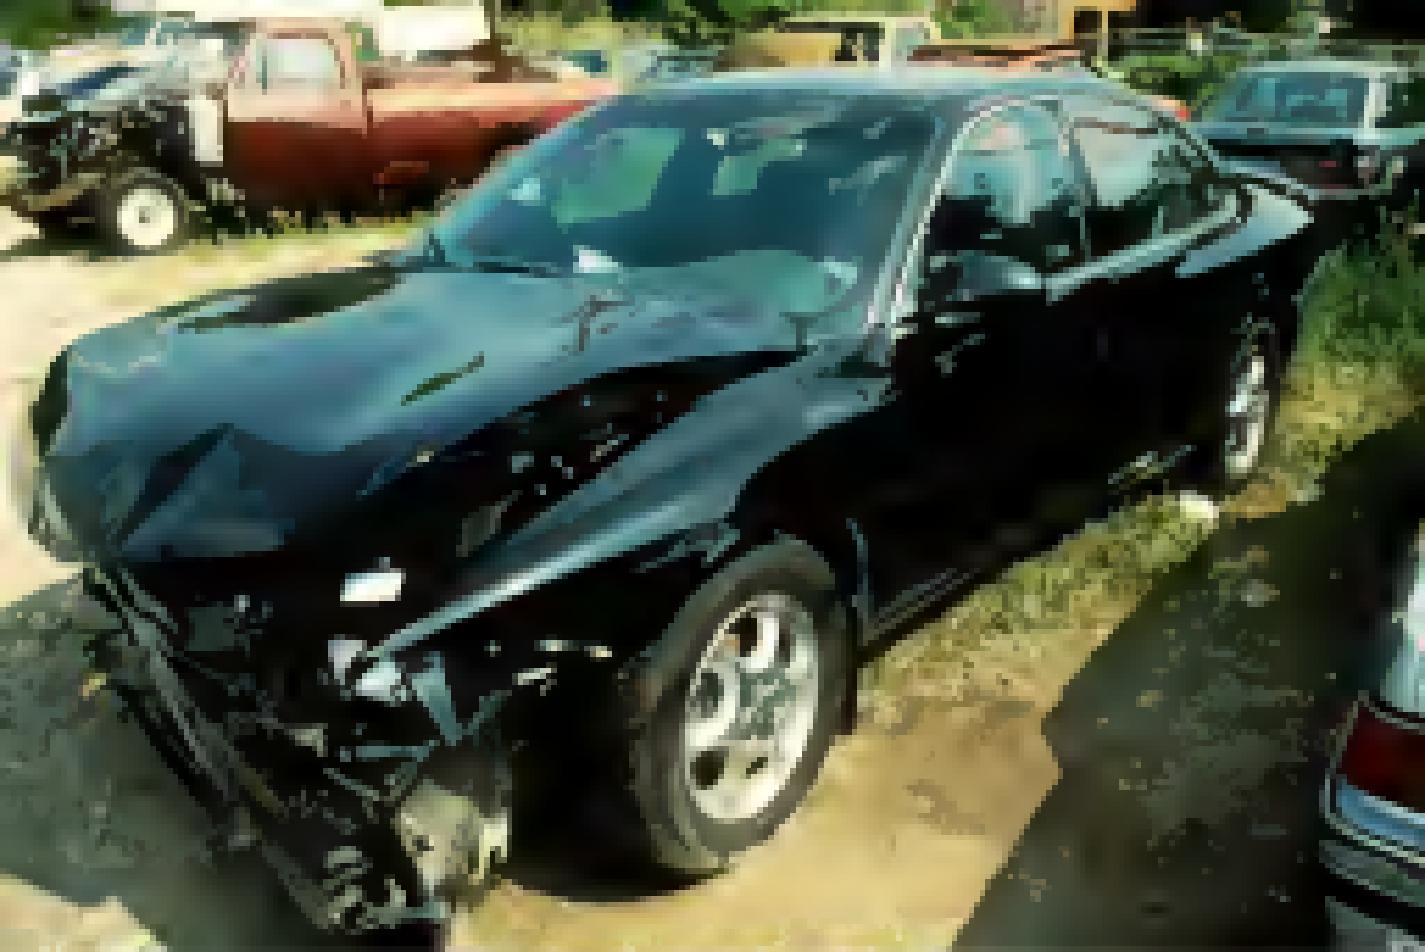
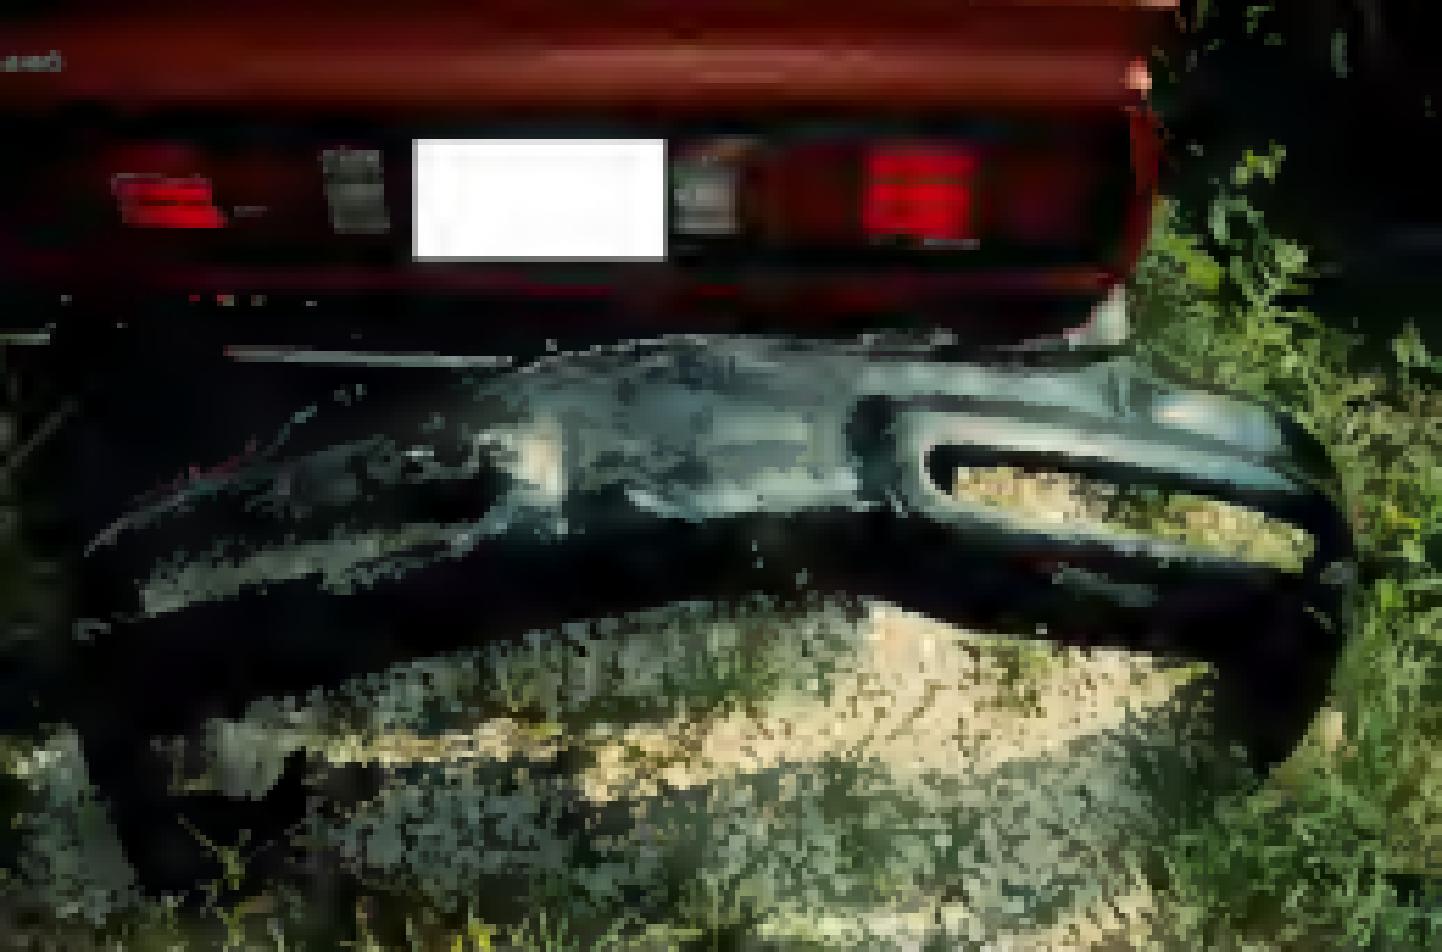
(Slides 9, 10, 11, 12, 13, 14) Damage to case vehicle (A) was moderate. Direct-damage length was 141 cm and began at the right-front bumper corner. The maximum crush was 29 cm and occurred 25-cm inboard from the right front bumper corner. The front bumper and headlight assemblies were damaged. The hood was crushed and the latch released. The left and right hood hinges were damaged, but did not separate from the hood. The rear edge of the hood was elevated, but did not contact the windshield. The right and left fenders were damaged. There were stress cracks in the lower right corner of the windshield.
